Complex Restoration of a Failing Dentition with Direct Composites

ABSTRACT

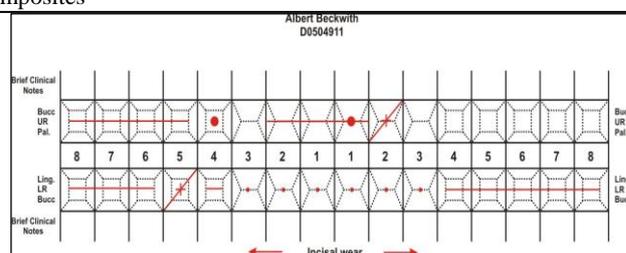
Figure 1:- Intraoral Charting

AB was referred by his GDP explaining that AB has been having problems with his upper and lower dentures and had a failing dentition. AB complained of food getting stuck under the palate of the upper denture and the lower denture had become “loose AB has had upper and lower partial dentures since the last 5 years and has wanted them replaced, as he was unable to eat with them . AB also explained since his last denture was made he had a fractured tooth on his lower right side (Fig 1). AB was diagnosed with capillary fragility 3months ago and is not on any medication.

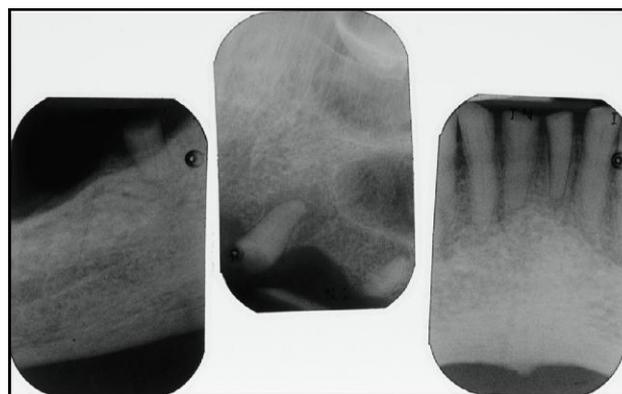
Figure 2:- Radiographs of the root stumps

On examination of the dentures the upper denture: Lacked retention stability and support and the lower denture showed that LR5 had fractured thus the purpose of the clasp to aid in retention was lost. Patient had had the dentures for 5 years and the dentures had good oral hygiene. The patient had a deep overbite with loss of occlusal vertical dimensions. The Radiographic Assessment of UL2 AND LR5 had fractured crowns and embedded and the root stumps also depicted periapical radiolucency with widening of the periodontal space. LR1, LR2, LL1, LL2 depicted reduced coronal height (Fig 2).

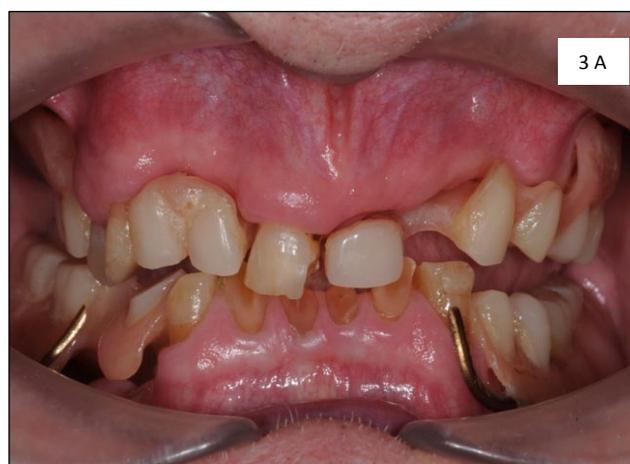
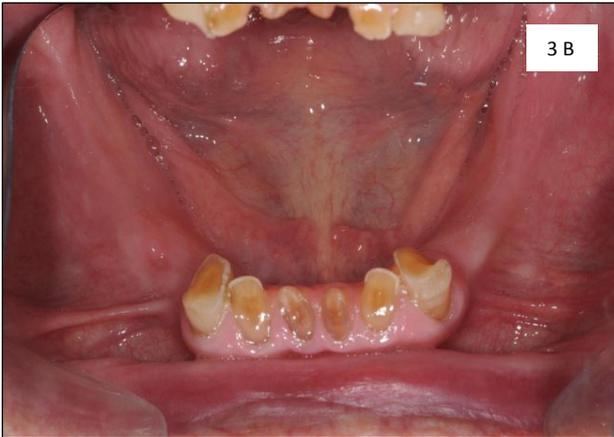
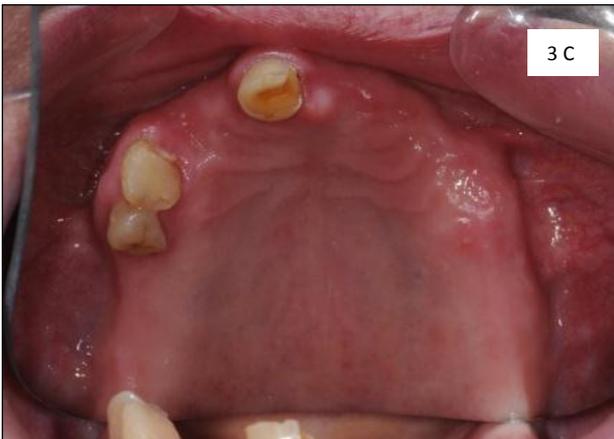
Figure 3A, 3B, 3C: Preoperative Photographs

Tooth wear: A combination of erosion and attrition affecting the upper and lower anterior sextants with a loss of Occlusal vertical dimension (OVD) due to missing posterior teeth and loss of tooth structure anteriorly and failing dentition (Fig 3A,3B,3C).

Teeth wear: The patient's primary complaint was not tooth wear. However, the restoration of the function without addressing the failing dentition was impossible. The tooth wear in the patient was characterized by "cupping" of the incisal edges thus indicating that the frequent regurgitation may have caused erosion on the teeth surfaces.¹ The presence of the reduced clinical crown height may be another indicator of attritional wear from grinding habit.¹ The patient also displayed "over closure" and decreased anterior facial height as a result of loss of occlusal vertical dimensions (OVD) due to the pathological wear. Tooth wear has also been associated with age, in a study conducted by Van't Spiker et al found that the percentage of wear increased from 3% at age 20 to 17% at age 70.¹³

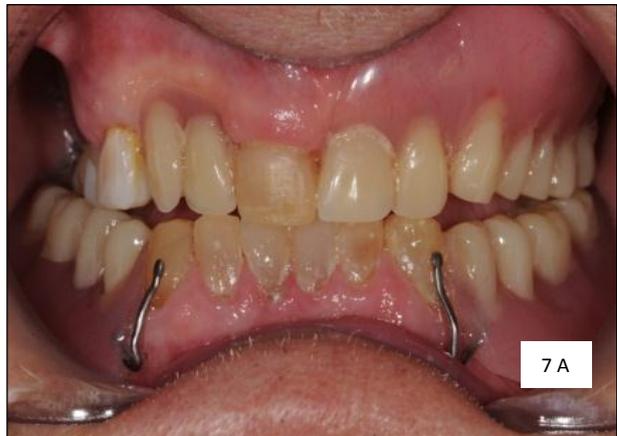
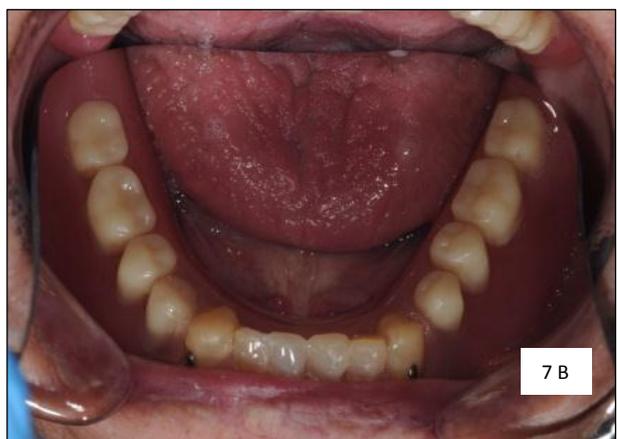
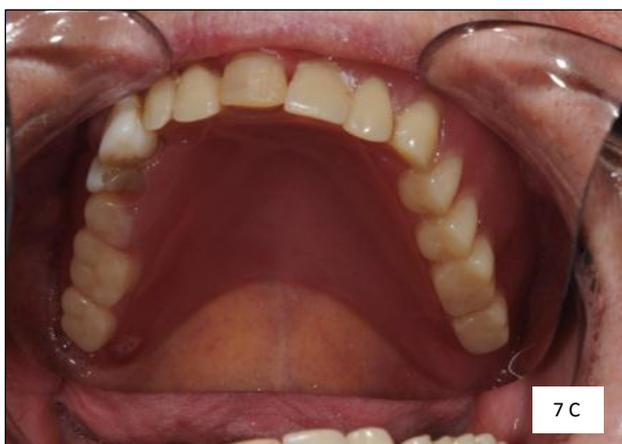
Fig 7A, 4B, 4C: Post Operative View

Once the patient was able to tolerate the increased OVD, the composite buildups were placed on his teeth. The patient was pleased with the esthetic, retention and

stability of the dentures and restorations (Fig 7, Fig 8). The patient prior to treatment was informed about the possible wear, fracture and debonding of the composite which are liable to happen in this kind of approach.¹ Acrylic resin and composite were used as materials of choice as they are inexpensive and easy to fix in case of fracture. However, providing definitive restorations using metal ceramic crowns with palatal metal surfaces may be considered in the case of composite restoration failure. Regular recall and maintenance visits have been advised to ensure the longevity of the restoration. The patient has also been instructed and advised about the importance of oral and denture hygiene routines.

A removable partial denture was used in the management of tooth wear that might have been difficult to restore. An increased OVD was achieved by the placement of the upper and lower dentures, which has provided space for the placement of composite restorations. As a result the removable partial dentures helped restoring the lost vertical dimension.

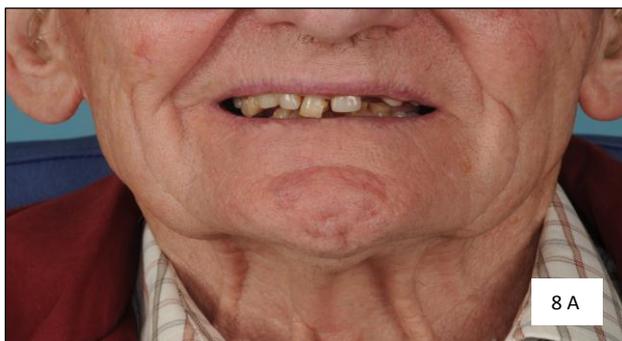
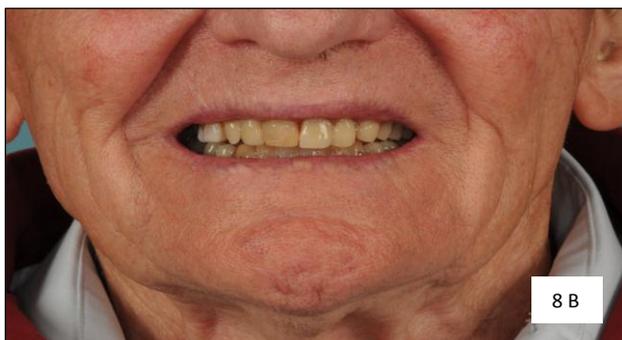
Figure 8A, 8B: Comparative facial views of the patient

AB has frequent regurgitation of food after his meals and is currently being investigated for the same by his GP. On extra oral examination lower facial height was reduced.
