An Improved Case of LASER Sintered One-Piece Dental Implant with Early Failure Signs

Early loading of dental implants can simplify treatment and increase patient's satisfaction. In a study designed to evaluate laser-sintered early-loaded one-piece implants, in the mandibular premolar area, early signs of implant failure were noticed in one patient (out of 30 cases), based on clinical and radiographic evaluation. A piece of amalgam restoration had fractured during implant site preparation and was trapped into the peri-implant tissue. The case was followed up frequently and the preimplant tissue was irrigated with saline at each follow up visit. Antibiotic (Amoxicillin; 500 mg 3 times/day; for one week) was prescribed in an attempt to prevent the development of soft tissue infection and subsequent bone resorption. Then, the patient was maintained on a combination of 20 mg sub-antimicrobial dose doxycycline and 30 mg Coenzyme Q10 twice/day for 3 months. The patient was instructed to adhere to strict oral hygiene measures and come for follow up every month. At 3 and 6 months of follow up, there was minimal additional bone loss of 0.01 mm, negative bleeding index, periotest reading was

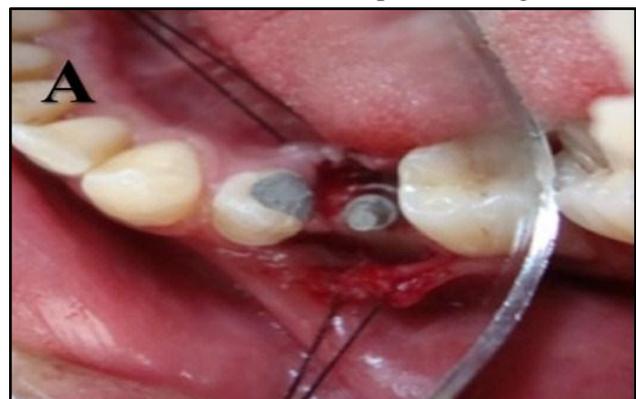
Fig A: A photograph shows a raised flap and two retraction sutures with the implant in place

traction sutures were placed to expose the alveolar bone. The mandibular left second premolar site was prepared following the instructions of the implant manufacturer and under abundant saline solution irrigation. Initial preparation was performed through the surgical guide while the subsequent drilling was performed after guide removal. Initial drilling was performed with 1.8 mm pilot drill and subsequent drilling was completed with 2, 2.5 and 3 mm drills under constant saline irrigation. After irrigation of the osteotomy site with saline, the one-piece dental implant was placed and secured in place with a hand driver (Figure A). The flap was replaced and sutured without tension with 3/0 silk suture. An acrylic temporary crown was fabricated and cemented with temporary cement. The patient was instructed to have soft diet for the first 3 days and to return after one week for suture removal and secondary impression. The patient was prescribed an antibiotic (Amoxicillin, 500 mg 3 times/day) for a week and Oflam 50 (Diclofenac Potassium; MephaPharma, Alexandria, Egypt) was prescribed to the patient when needed. Early loading with provisional restoration was performed within 48 hours after surgery and immediate postoperative periapical radiographs were taken to act as baseline for measurements of marginal bone loss at follow up periods (Figure B). After a healing period of 4 weeks, the implant was functionally loaded with its permanent crown. The patient was recalled for regular follow up appointments for evaluation; at 1, 3, 6, 12 and 24 months after implant loading.

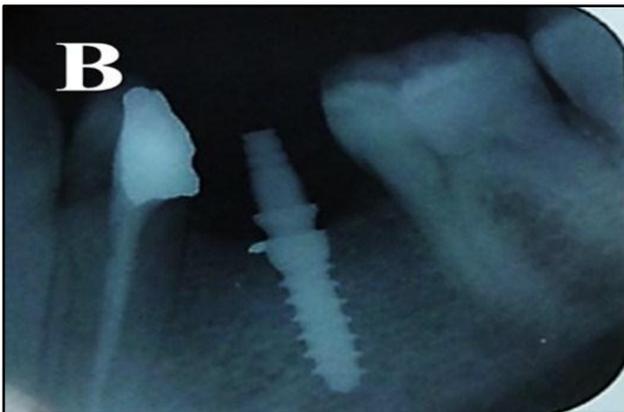
Fig B: A periapical radiograph shows the implant after initial placement.

The immediate postoperative periapical radiograph (Figure B) showed a small piece of amalgam, most

probably from the adjacent first premolar, trapped subgingivally at the implant site. Frequent irrigation with saline was performed to remove this trapped piece of amalgam, however, all attempts failed. We decided not to do further intervention to remove it; to avoid disruption of tissue healing and osseointegration. Four weeks after initial implant placement, the patient showed signs of implant failure that included gingivitis, gingival recession (Figure C) and positive gingival bleeding index. The periostest was used to measure the implant stability and the recorded reading was +2. Periapical radiographs analysis showed 2 mm mesial marginal bone loss and 0.5 mm distal marginal bone loss (Figure D). The patient stated that he did not take the medication prescribed to him after surgery and was neglecting all oral hygiene measures instructed to him. The case was considered a failed implant and we expected more bone loss, however, the patient decided to keep the implant and follow up on it.

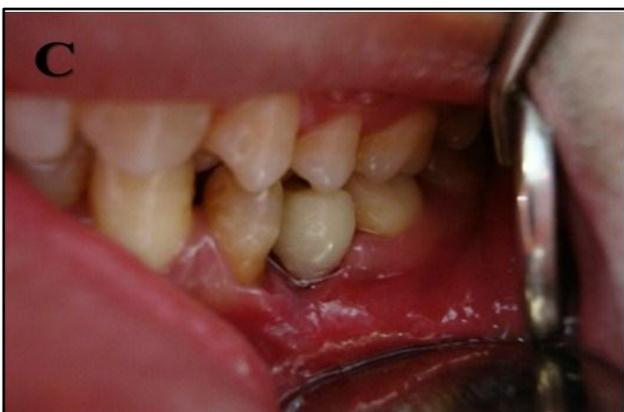
Fig C: a photograph shows the permanent prosthetic restoration in place and in occlusion, 4 weeks after initial implant placement, the patient shows signs of gingivitis and gingival recession around the implant and the first premolar

The temporary crown was removed to avoid irritation of the soft tissue with acrylic crown. A permanent metal ceramic crown was placed to check occlusion and cemented, then the patient was instructed to use soft diet. The patient was prescribed an antibiotic (Amoxicillin, 500 mg 3 times/day) for a week and chlorhexidene mouthwash 3 times/day and he was referred to a periodontist to evaluate his periodontal condition. The periodontist performed necessary scaling and root planning. The patient was maintained on a combination of 20 mg sub-antimicrobial dose doxycycline (SDD; Alexandria Co. for Pharmaceuticals and Chemical Ind, Alexandria, Egypt) and 30 mg Coenzyme Q10 (CoQ10; BioMerieu SA, Marcy-l'Étoile, France) twice/day for 3 months. The patient was instructed to adhere to strict oral hygiene measures and come for follow up every month.

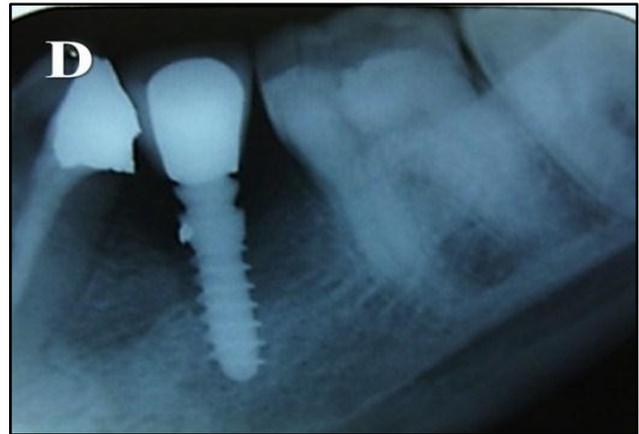
Fig D: A periapical radiograph shows levels of marginal bone loss around the implant after 1 month; 2 mm mesial and 0.5 mm distal.

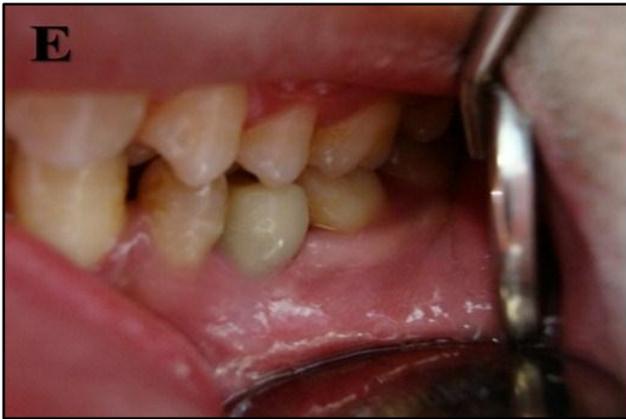
Fig E: A photograph shows the permanent prosthetic restoration in place and in occlusion, 24 months after initial implant placement.

At two month of follow up the patient showed positive bleeding index but less gingival inflammation. The periostest reading was zero and no more bone loss was observed. Therefore, we decided to leave the permanent crown in place and in occlusal contact with the opposing teeth. At 3, 6, 12 and 24 months of follow up, there were no signs of gingivitis (Figure E; after 24 months) and minimal additional bone loss of 0.01 mm (Figure F; after 24 months). The bleeding index was negative and the periostest reading was -1.

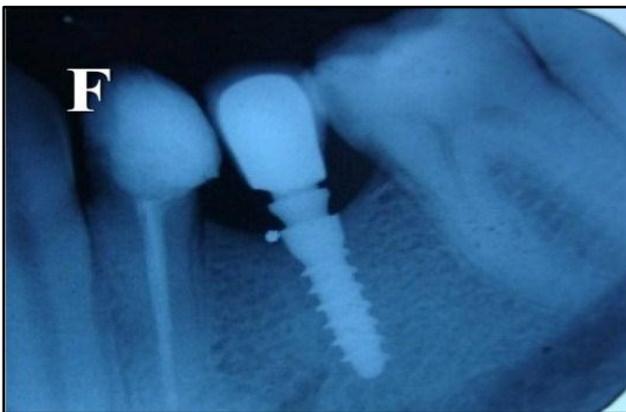
Fig F: A periapical radiograph shows the minimal additional marginal bone loss of 0.01 mm levels around the implant, 24 months after initial implant placement.
